## Development and Prototyping of Automotive Tricycle Brake Wear Rig and Sensor/Monitor

### Abstract

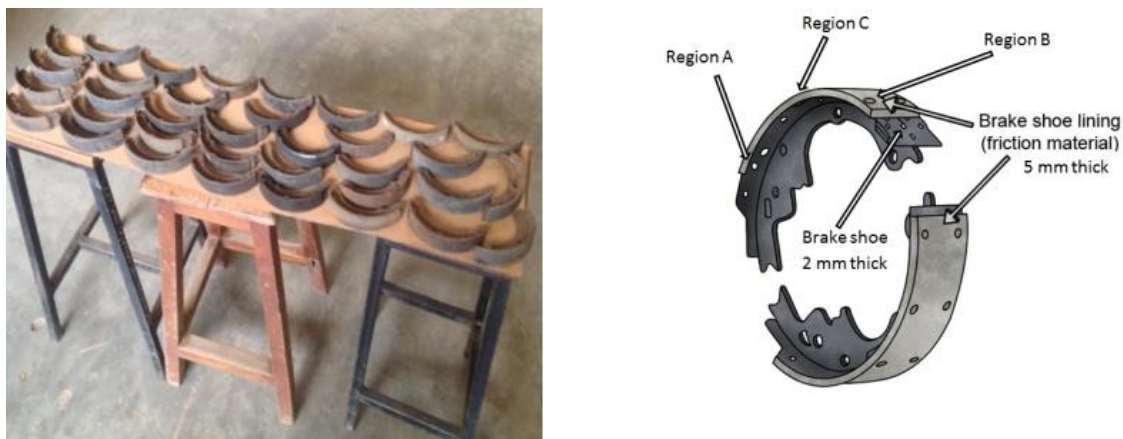
In the identification of the regions of high brake linings that produce high wear rates by some automotive tricycle; this study measures the thickness of 34 worn samples of brake lining as shown in Figure 1 (a). The regions on the brake linings where the height of worn brake linings was measured are shown in Figure 1 (b). The purpose of measuring the lining thickness is to compare the variations in the thickness of worn brake lining to new brake lining.

Figure 1 Tricycle brake lining; (a) collected 30 samples, (b) measured height of worn regions

A comparison of the thickness of the friction materials of a new brake material to old and worn linings of the tricycle is expected to give an indication of the parts or areas on the linings that mostly wear a lot. These worn samples are randomly collected from the tricycle's auto-mechanics around Ikorodu metropolis. A measurement of the thicknesses of worn brake linings at different locations and comparison with the thickness of new linings enables this study to locate a brake wear sensor at appropriate locations on the lining (Guan XU, 2013). This is possible using a digital vernier caliper.

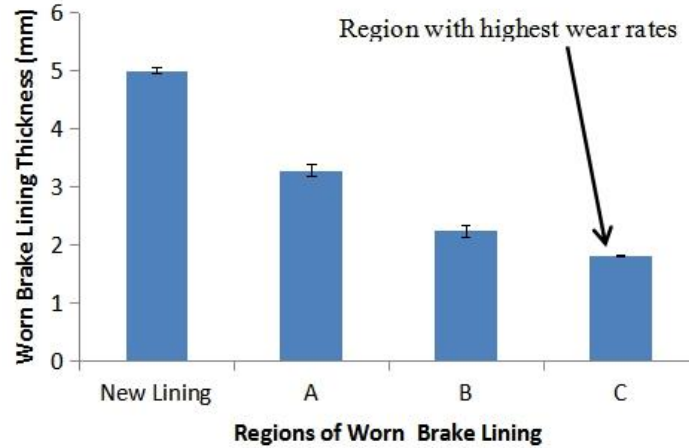
The results of wear rates comparison of worn brake linings to new or unworn brake friction materials based on their height differences are shown in Figure 2. This result indicated that progressive loss of materials on the brake linings of automotive tricycles wear most around region C or the central area of the lining that is comparable to results of similar studies on brake pad (Sivarao et al., 2009); where the high wear rates of the brake friction materials were found to take place around the central region of the brake pad. However, this was attributed to its closeness to the actuating piston (wheel cylinder).

Figure 2 Identification of wear pattern on different regions of the brake lining

The results of a similar study attributed high wear rates in a certain region to abrasive wear mechanisms (Straffellini & Maines, 2013). From the evaluated data sets of automotive tricycle brake friction materials, results shown in Figure 2 indicated that region C of the brake lining is a more suitable spot to embed a wear limit sensor.
