## Effects of Ground Water on Dampness of Building in Ede Township

Adewumi, B. E., Adeyi, S. A., Familusi, A. O., Olusami, J. O., and Ogundare, D. A

<sup>1</sup>Department of Civil Engineering Technology, School of Engineering, Federal Polytechnic, Ede, Nigeria

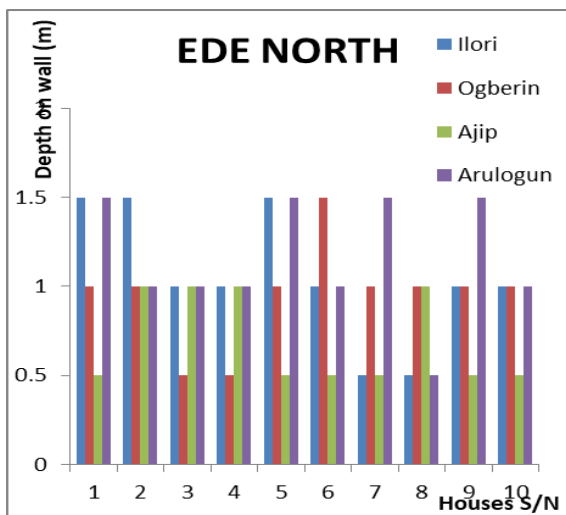
1(a)

**Figure 1a & 1b: Variation in the Level of Dampness on Walls in Ede North & South**

Similarly, table 5 shows that dampness rose to 0.50m in 29% of houses in the study area, 1m in 49% of houses, 1.5m in 20% of houses and 2m high in 2% of the buildings respectively in the northern region. This indicates that 98% of the building is damped at 1.5m above the ground.
