Effects of Soil Drainability on the Dampness of Buildings in Ede Township

Abstract: Despite the lasting qualities of buildings, all buildings, be it old or modern types of construction are susceptible to natural and man-made mechanisms of deterioration. Of all defects associated with buildings, moisture is the most common and frequent, and this contributes to more than 50% of all known building failures. This research investigates the effect of soil drainability on dampness in buildings in Ede Township. Quantitative method and field test were used, one hundred (100) questionnaires were administered to residents of the study area, and double ring infiltrometer equipment was used to determine the rate at which water infiltrates into the soil according to ASTM D3385-03 standard test method. The study shows that 84% of the buildings surveyed were damped and 57% of the damped buildings became dampened a year after construction. Despite the fact that 44% of the buildings have damp proof membrane installed, yet most of them became damped due to poor workmanship. The infiltrometer and moisture content test confirmed that the two soil types found in the study area include sandy and sandy l

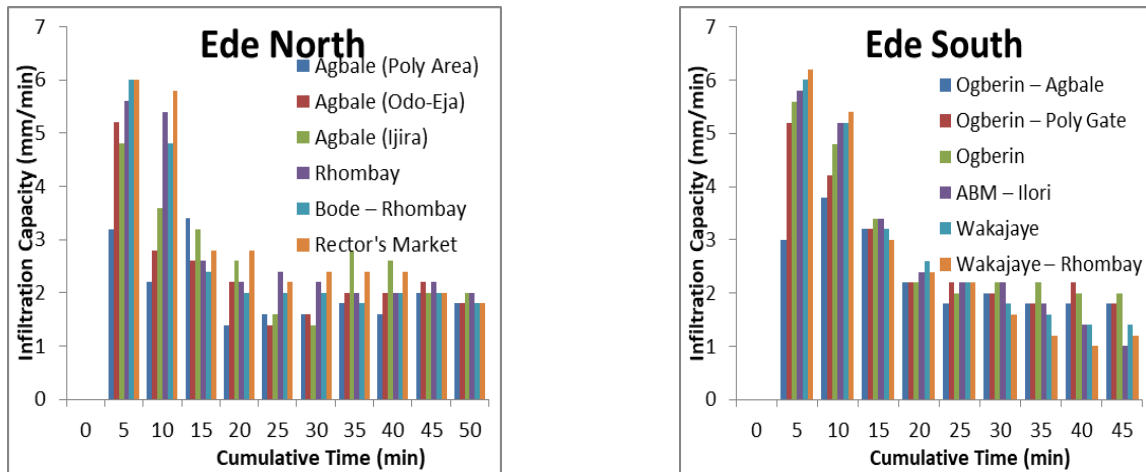
Figure 1a & 1b: Variation of infiltration rates at different locations in Ede North & South
1(a) **1(b)**

system in place, it will increase the rate at which erosion is generated which might lead to flooding in the nearest future. The variation in water infiltration rate is shown below in Figures 1a and 1b respectively.
